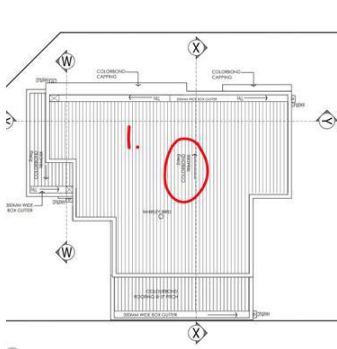
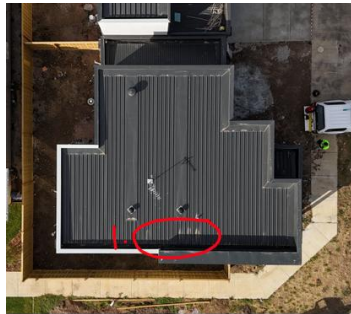
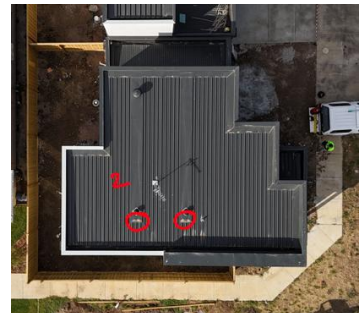
- 1. Roof pitch not achieved as per approved plans. Roof sheets are damaged/creased causing ponding on the roof sheets.
- 2. Flashings not free draining as screws have flattened the flashing.

Refer to AS 3500.3: Plumbing and drainage Part 3: Stormwater drainage section 4.4.3 Corrosion due to crevices:

"Metal roof drainage systems and support systems shall be designed and installed to achieve complete drainage or drying. Shielded areas capable of causing permanent ponding shall be avoided to prevent the possibility of intense localized corrosion known as crevice corrosion.

NOTE: This type of attack results from contact of metal with moisture and salts under oxygen-deficient conditions in which trapped moisture cannot readily evaporate. It can be caused by lap joints, absorbent gaskets, holes, crevices under bolt or rivet heads, or surface deposits, including non-metallic materials such as elastomeric materials, plastics, fabrics, lifted paint films or accumulated solids"

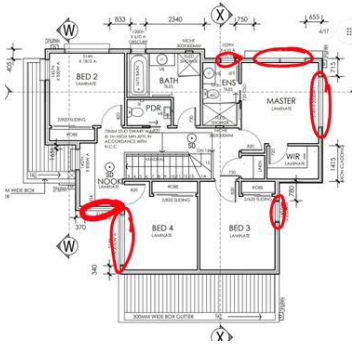
2.4.2: Windows sealed

SIGNIFICANT DEFECT

Numerous gaps to all windows, all to be reviewed

Windows not sealed.

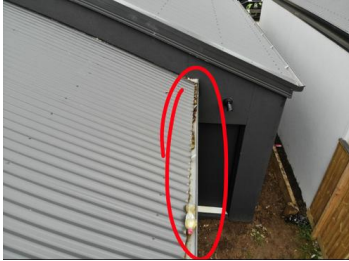
Photo 64

DEFECT

Debris visible in gutters.

AS 3500.3: Plumbing and drainage Part 3: Stormwater drainage section 4.5.1 Installation:
"Installation of each new, or altered section of the roof drainage system shall be in compliance with the following:

- (a) There shall be no restrictions to the free flow of stormwater due to—
 - (i) protrusions or other obstructions; or
 - (ii) debris, e.g., cement, mortar, clippings, and similar.
- (b) All accessories shall be effectively fixed and securely anchored."

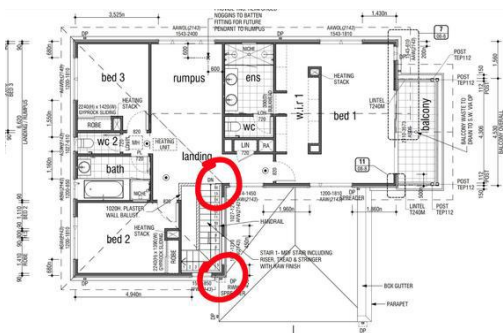
Photo 10

SIGNIFICANT DEFECT

Overflashings not installed X2 where soaker tray upstands penetrate through the roof tiles.

The Building Code of Australia Volume 2, Performance Requirement P2.2.2 Weatherproofing: "A roof and external wall (including openings around windows and doors) must prevent the penetration of water that could cause—
(a) unhealthy or dangerous conditions, or loss of amenity for occupants; and
(b) undue dampness or deterioration of building elements."

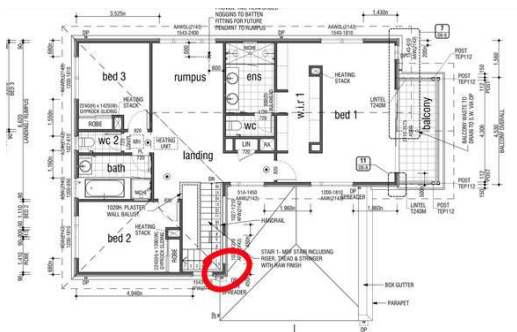
Photo 22

SIGNIFICANT DEFECT

Parapet capping minimum cover of 50mm not achieved and capping is gapped to wall allowing rainwater to enter.

Refer to Australian Standard HB39 Installation code for metal roof and wall cladding 8.1.4 Sizes and covers:

"The minimum cover over other materials and structures for roof flashings and cappings is given in Table 8.1.4. For jointing, see Clause 5.8."

"A roof and external wall (including openings around windows and doors) must prevent the penetration of water that could cause— (a) unhealthy or dangerous conditions, or loss of amenity for occupants; and (b) undue dampness or deterioration of building elements."
